DEPARTMENT OF NATURAL RESOURCES

Environmental **E**mergency **R**esponse

Belle Fountain Ditch Glycerin Release

Inspection Process

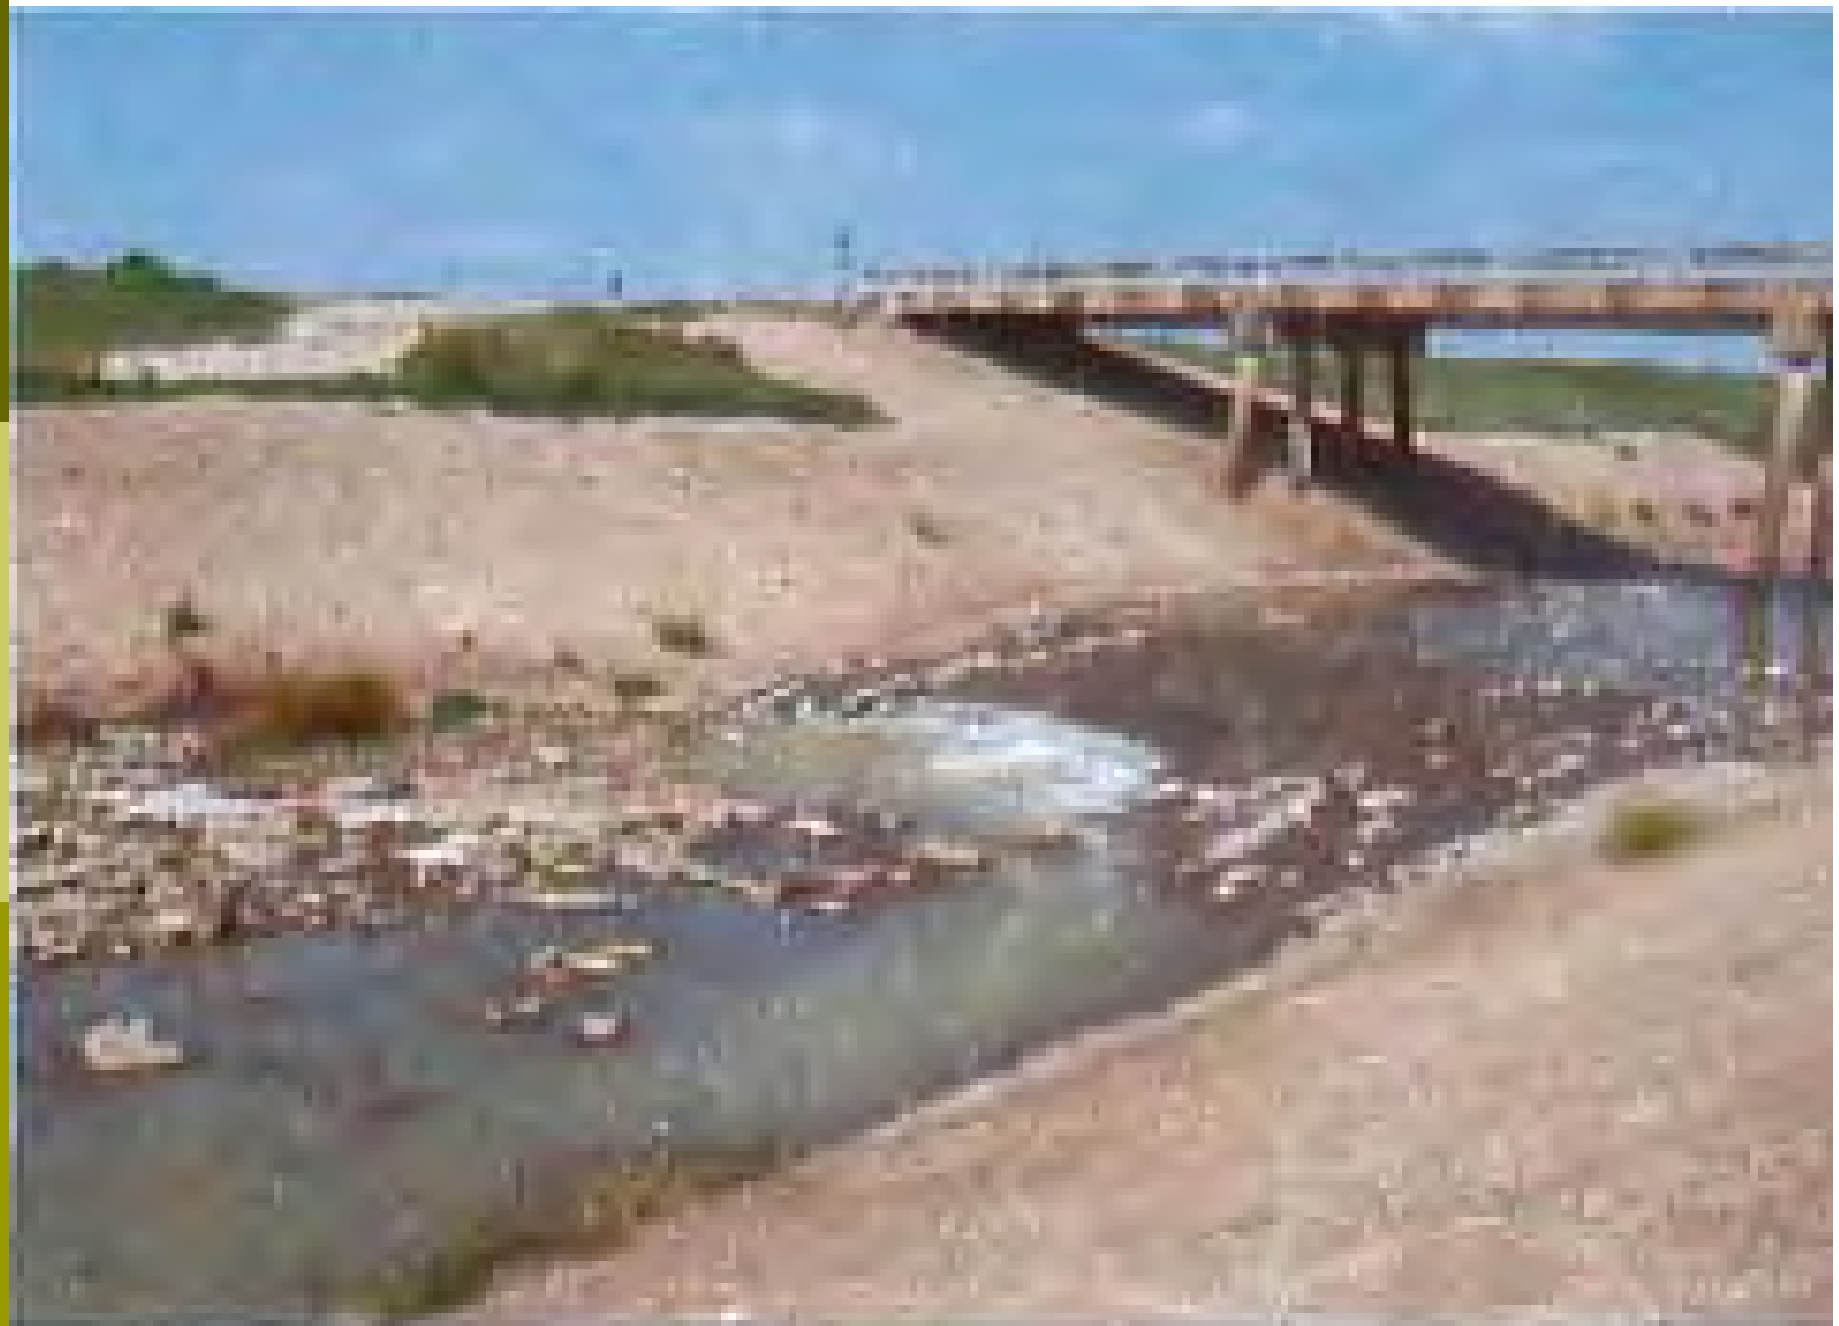
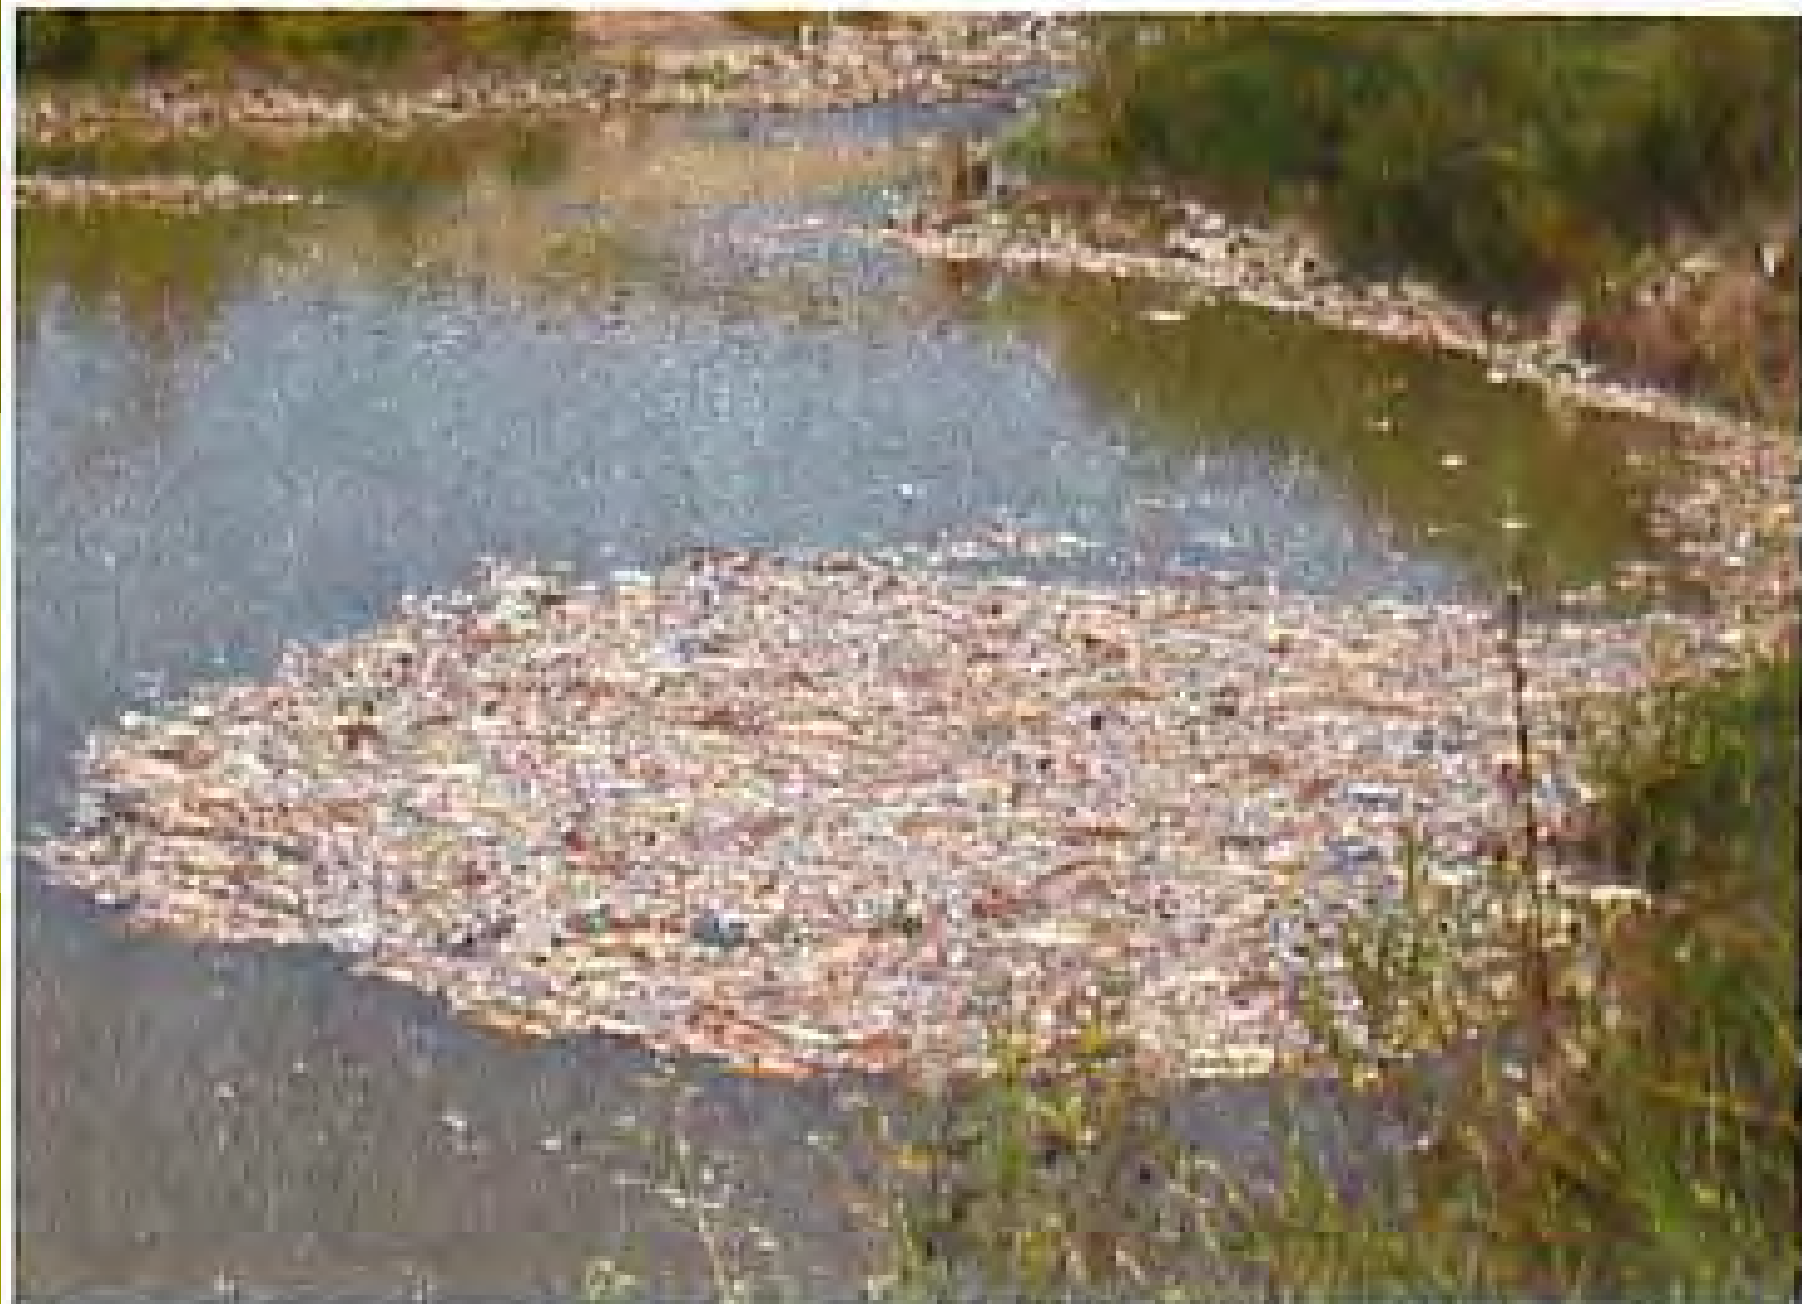
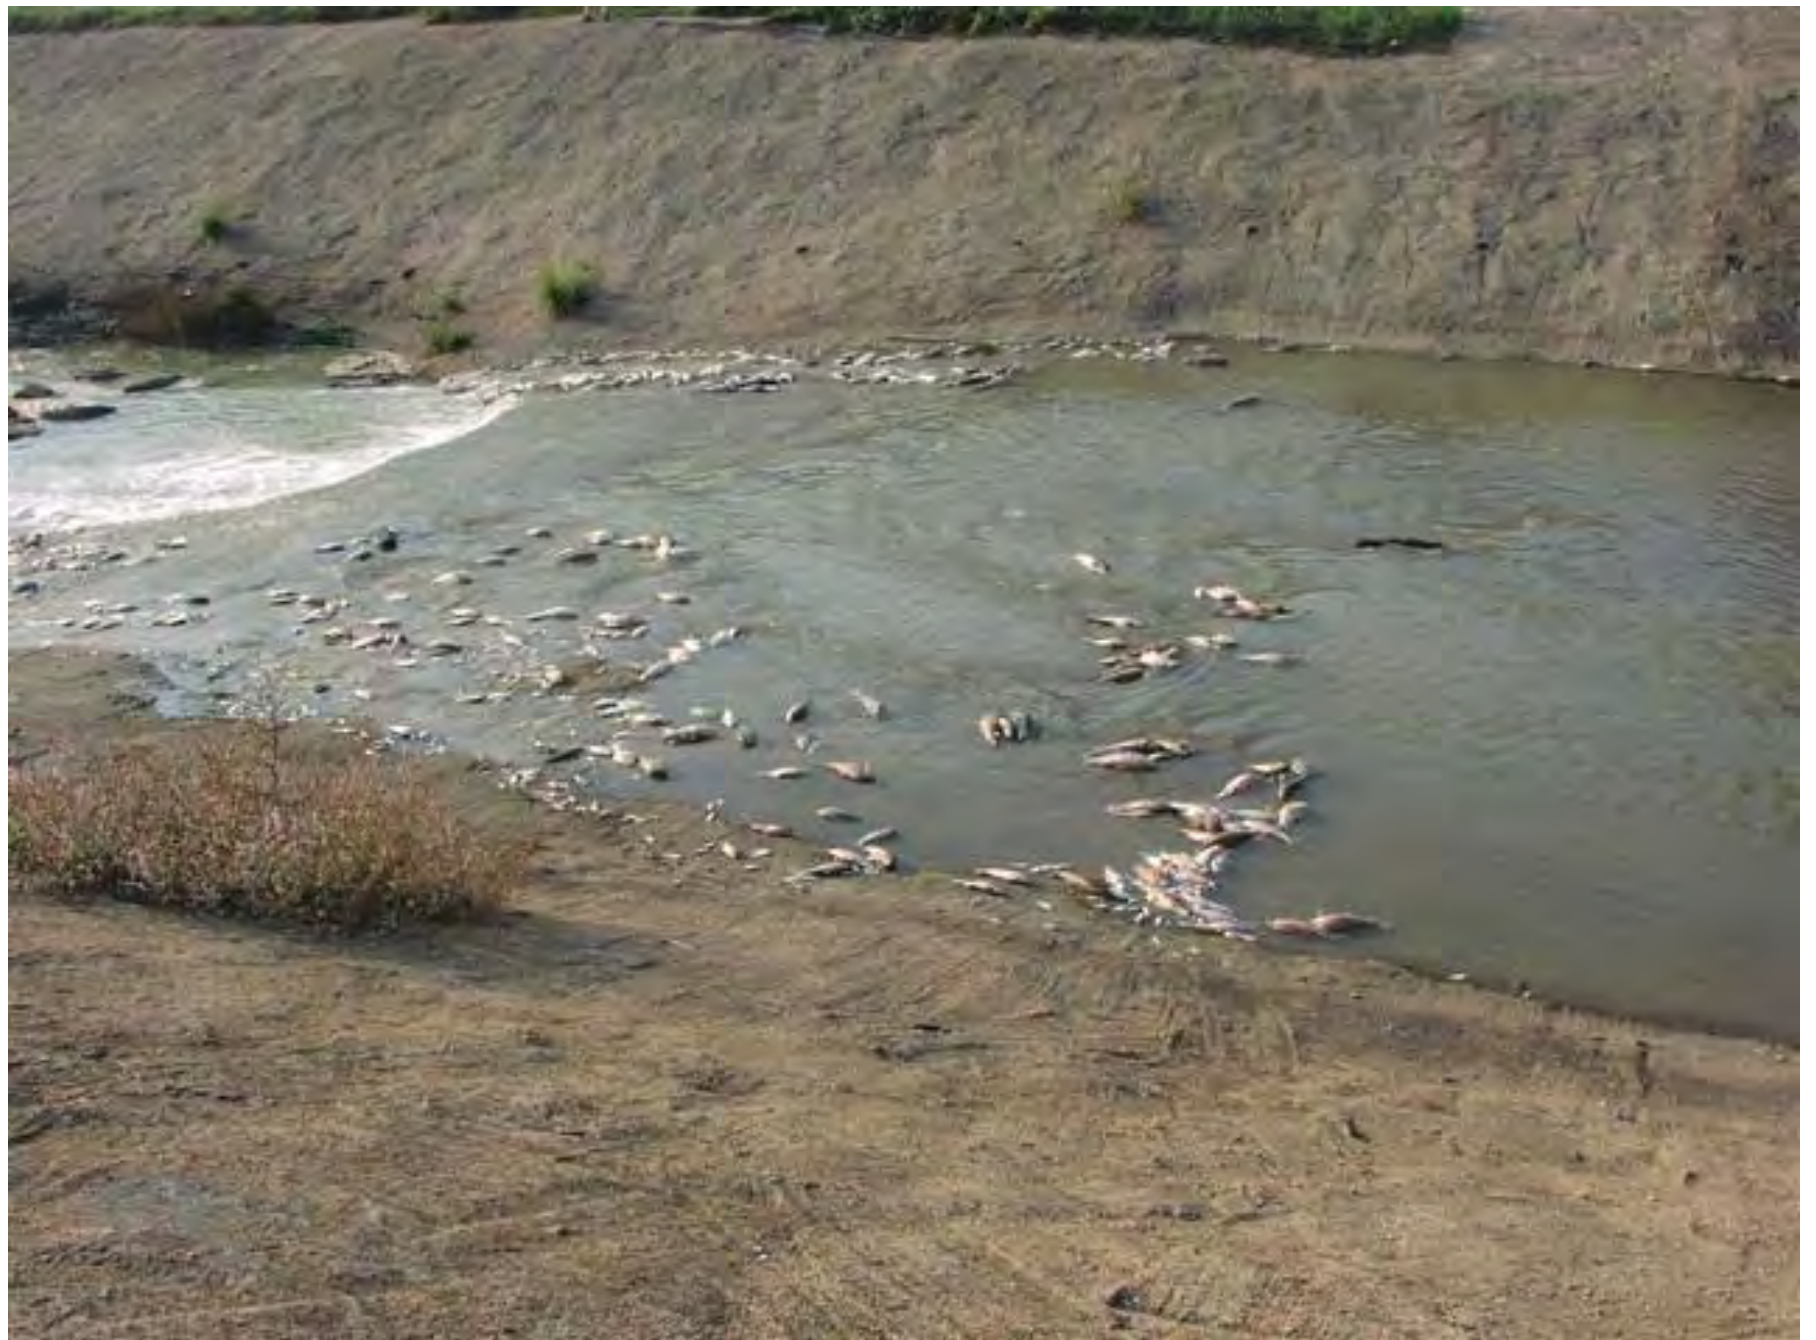
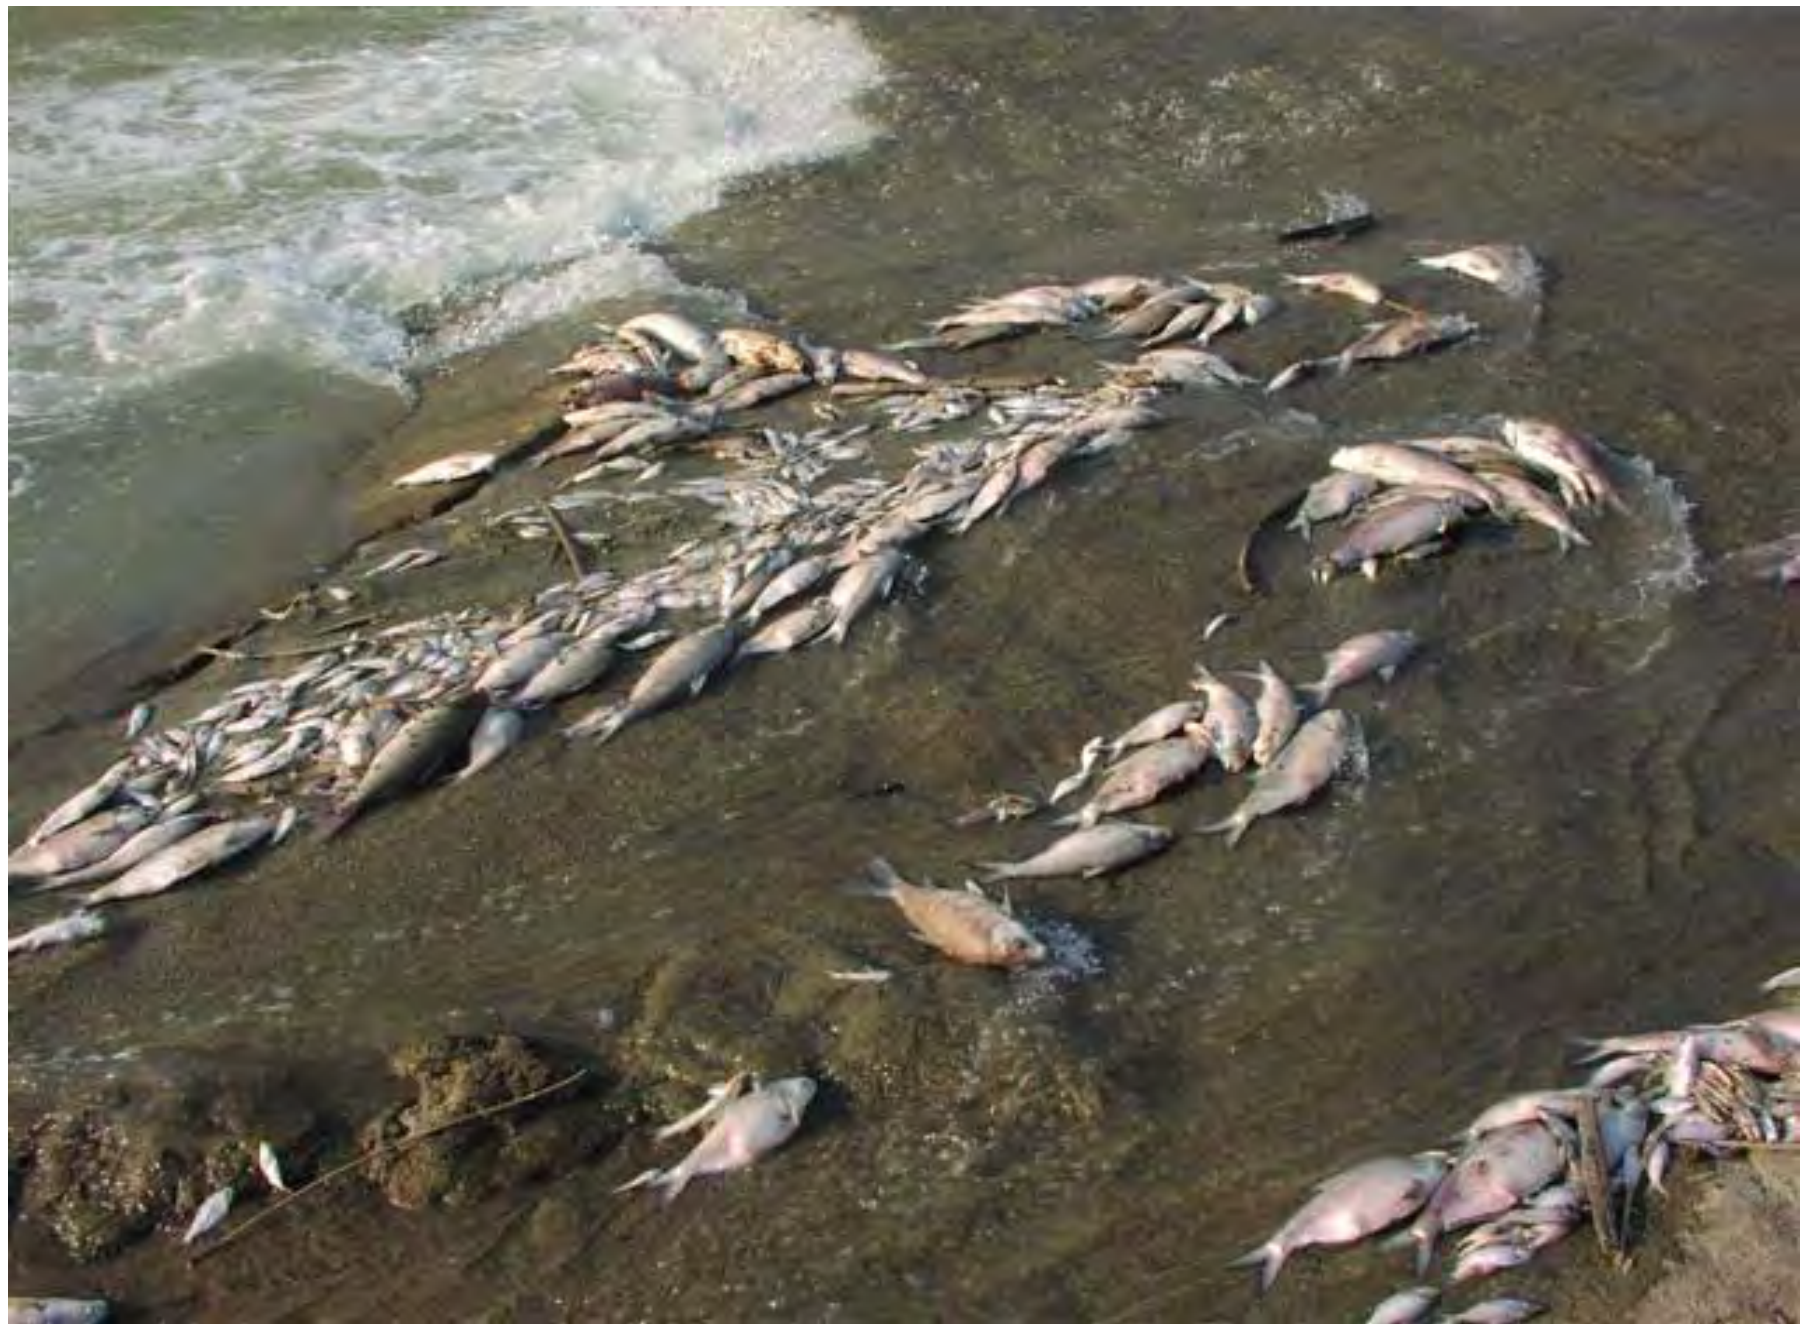
Belle Fountain Ditch

- ❑ EER Spill Line notified of large fish kill on 9/30/07
- ❑ Additional calls and investigation led to finding unrefined waste glycerin in agricultural field ditch.
- ❑ Field ditch was tributary to Waters of the State.
- ❑ Runoff from waste entered the stream.
- ❑ RP was in the Biodiesel Production Industry.
- ❑ Land application of glycerin was conducted, along with an additional dumpsite found.

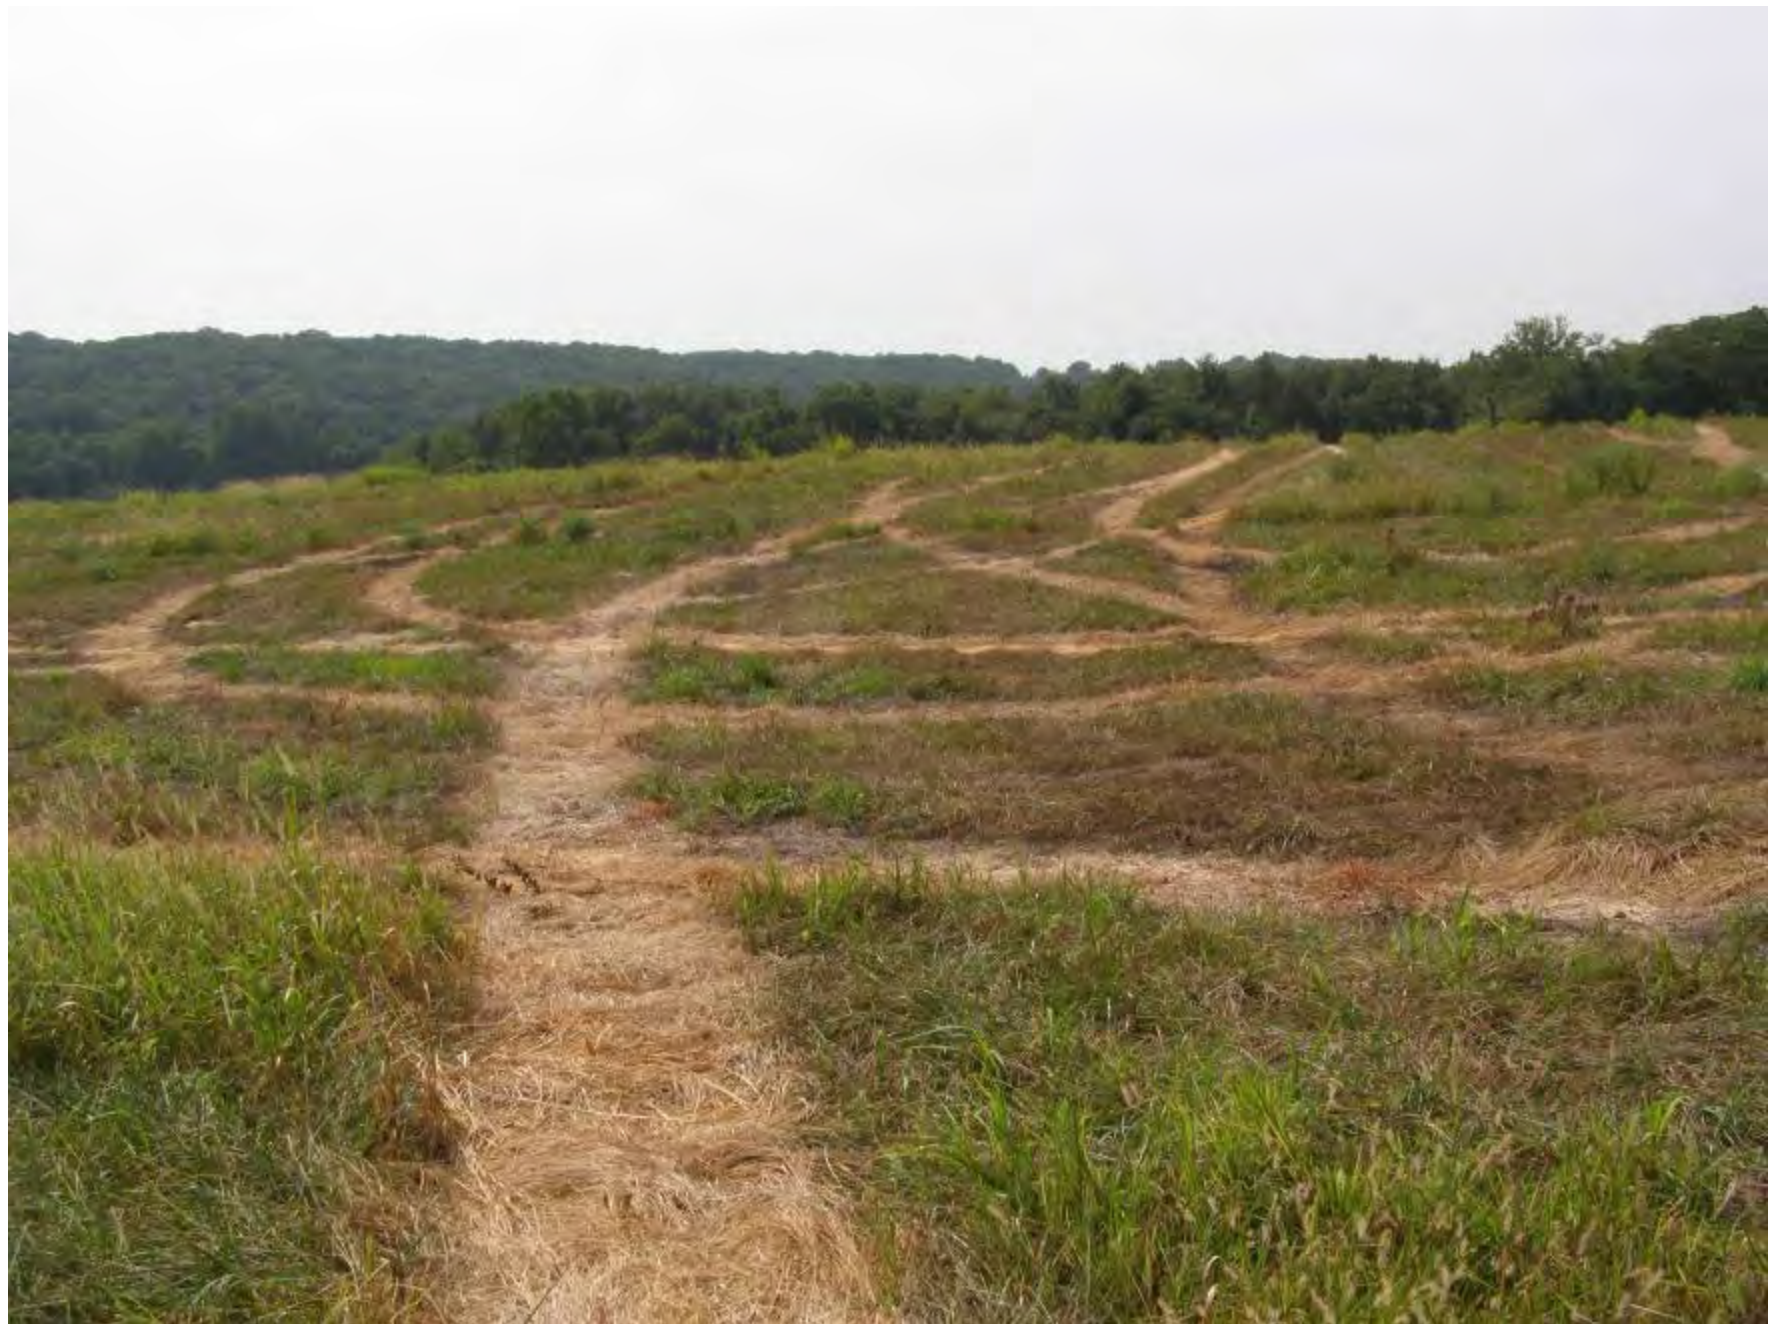
- ❑ Contaminated soil was covered in plastic
- ❑ Investigation revealed soil was not homogeneous, “clumps” of unincorporated glycerin still present.
- ❑ Methanol content within these clumps exceeded our Default Target Levels for ground water and drinking water protection.

- ❑ Initial thought was simply to require all of the soil to be landfilled
- ❑ Applicant sought to land apply everything

- ❑ Decided to allow bioremediation treatment of *most* of the soil
 - “clumps” of glycerin hauled to landfill, department staff overseeing visual segregation
 - Area receiving land applied soil bermed to prevent storm water runoff, and prevent runoff
 - Soil spread in treatment cell, allowing glycerin and methanol to break down

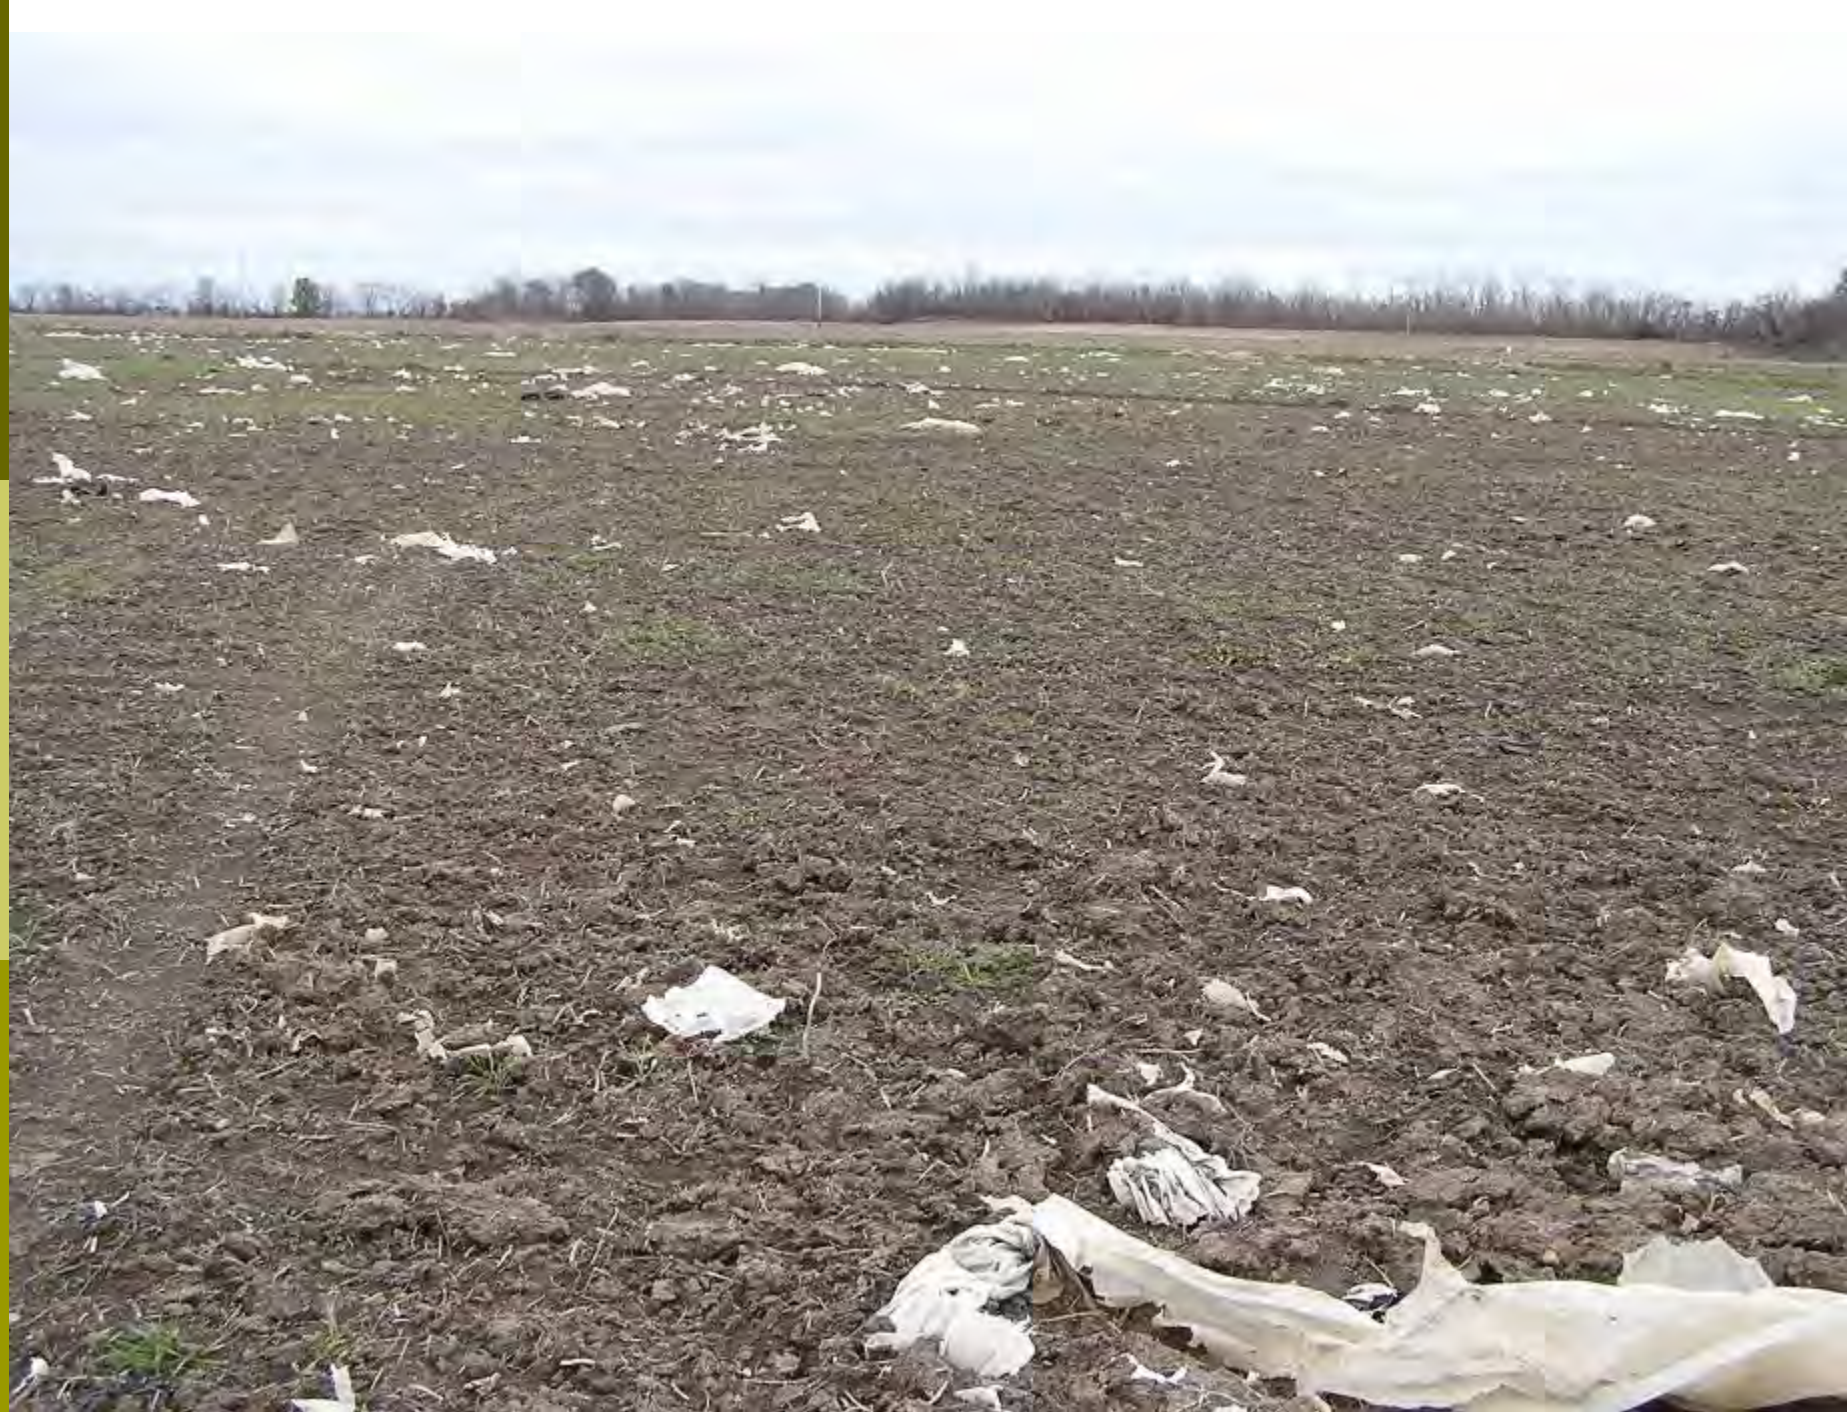
- ❑ Permit required soil samples taken from the treatment cell to verify methanol is gone
- ❑ Vegetation must be established
- ❑ However...

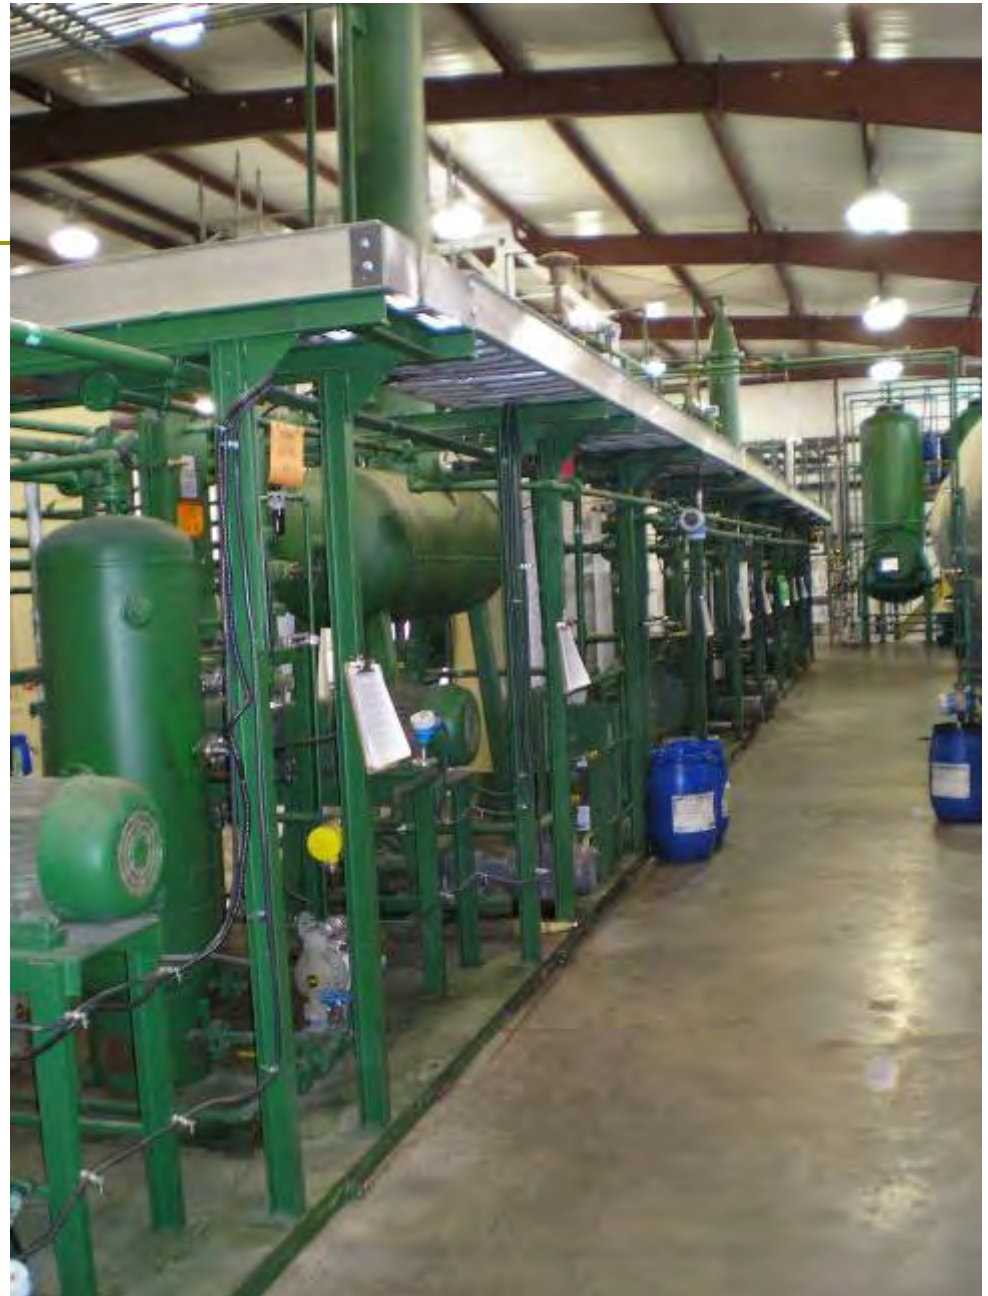
- ❑ Inexperience of manufacturers.
 - Many were farmers, small business owners and/or entrepreneurs with little or no experience in fuel manufacturing.
- ❑ The sudden and rapid growth of the industry.
 - The plants are relatively simple and easy to construct.
 - The facilities basically consist of a large metal building, secondary containment and a tank farm. The rest of the equipment is brought in on skids and put together on-site.

Plant equipment is brought in on skids and put together on-site.
